#### STABILITY OF SWELLING CLAY EMBANKMENTS

Presented at the 29th Canadian Geotechnical  
Conference  
Vancouver, British Columbia  
October 13 to 15, 1976

The long history of slope instability in Regina clay has prompted an in-depth study of the embankments at Belle Plaine, Saskatchewan. This paper presents the history, material characterization and analysis of the landslides at Belle Plaine.

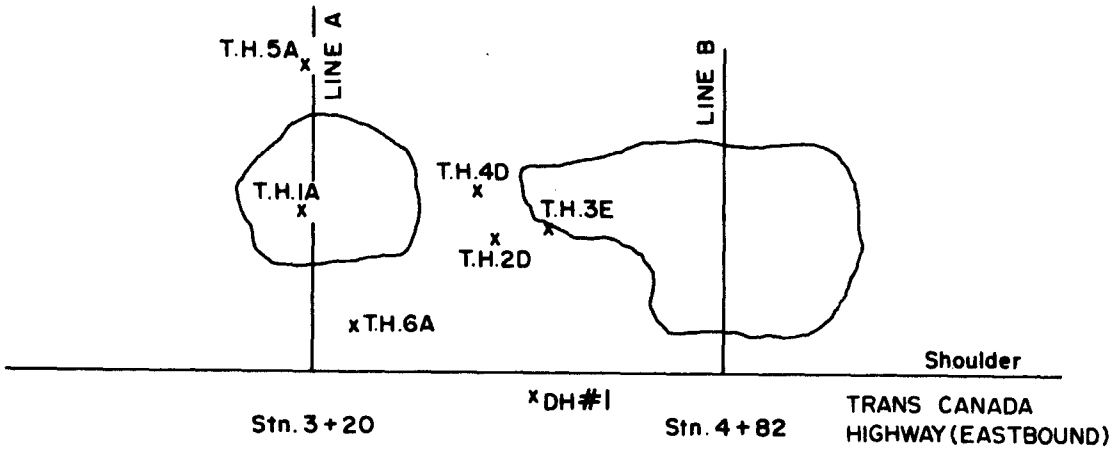
FIG. 3 SLIDE AREAS AND TEST HOLE LOCATIONS, BELLE PLAINE

In the spring of 1973, two landslides occurred on the northwest face of the eastbound lane (Point 'e'). The Authors visited the site for the first time in the fall of

1973. The landslides were surveyed and their locations are shown in Figure 3. Figure 4 is a cross-section along line A showing the scarp and the toe of the slope failure. Line B ran through the centre of the larger slide which appeared to be a small rotational slide at the toe of the fill and a series of sloughs above the original slide. Figure 5 shows the landslides along lines A and B, viewed perpendicular to the embankment.

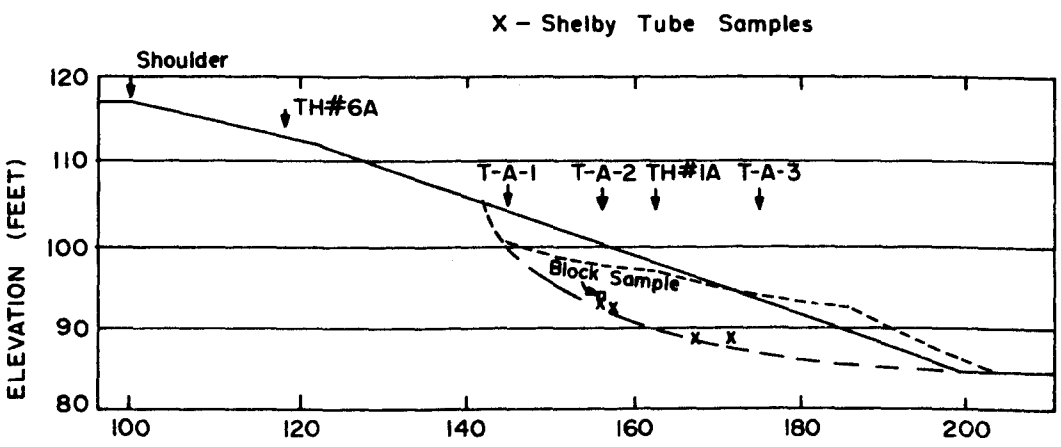
FIG. 4 CROSS SECTION ALONG LINE A

A backhoe was used on May 16, 1974 to make a trench approximately 8 feet (2.4 m) deep through the slide along line A. The scarp could be readily observed for the first 4 feet (1.2 m) into the fill. Due to the wet, fissured nature of the clay, it was difficult to accurately determine the remainder of the slip surface. The highly disturbed zone indicated that the base of the slide was approximately 7 to 8 feet (2.1 to 2.4 m) below the surface. The failure surface was essentially circular with the exception of the base portion which was slightly composite due to the thaw front. The toe slid out horizontally over the natural ground. Ice lens were encountered in some of the fissures and the backhoe dragged out large, frozen chunks of clay. A definite change in the soil structure from "nuggetty" to "massive" was noted between the top and bottom of the trench. Water content samples were taken at 6 inch (152 mm) depth intervals along the side of the trench. From three profiles (T-A-1, T-A-2, T-A-3), along the trench (Figure 4), the average of 34 water contents was 36.6 percent (Figure 7).
