# Performance of Darke Hall, Regina, Canada, Constructed on a Highly Swelling Clay

**SUMMARY** A case history describing the performance of a lightly loaded structure supported by a shallow foundation in an unsaturated expansive soil is presented.

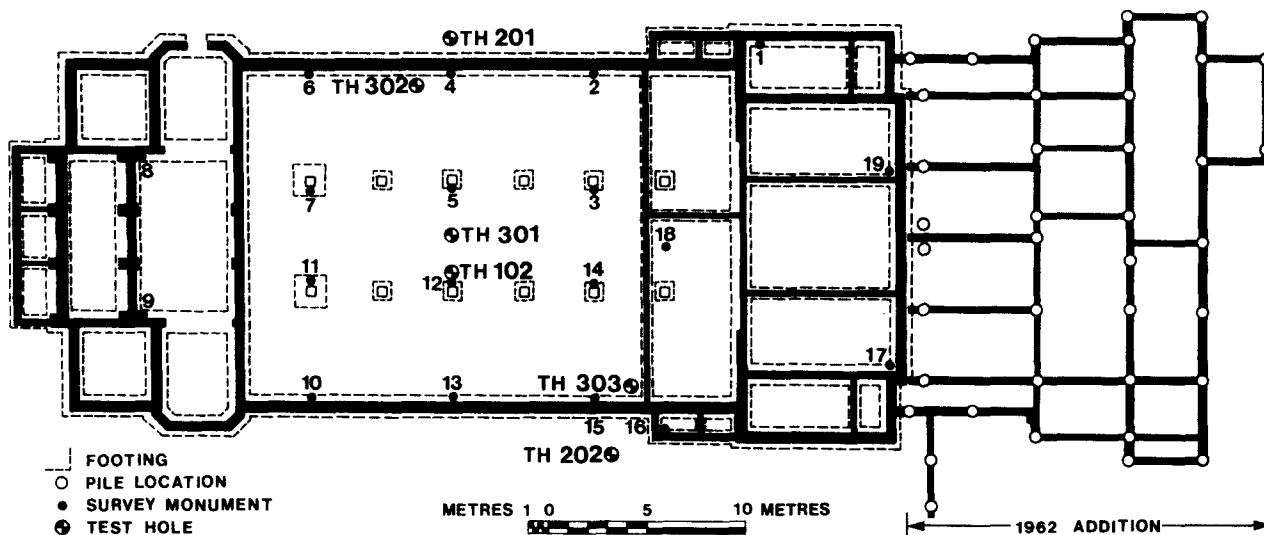
Figure 2 Foundation Plan Showing Locations of Test Holes and Survey Monuments

A network of brass plugs to monitor column movements was installed in 1951 and monitored in 1961, 1962, 1963, 1964 and 1965. Some cracking occurred during all phases of the building's life, but this was generally repaired by normal maintenance. However, increased cracking in the room partition walls in the basement was observed in the early 1960's. The results of a survey and recommendations made at that time suggested that the interior columns were moving downward with respect to the exterior footings. This may represent settlement of the interior columns, heave of the exterior footings or a combination thereof. Since the benchmark was located within the basement, it too was susceptible to movement and thus the magnitude and direction of the movements could never be positively determined. The location of the brass monuments are shown on Figure 2.

A level survey was conducted on the few remaining brass monuments in March, 1982. The results indicated that the interior columns have moved upward between 20 mm and 120 mm relative to the exterior walls since 1965. Differential movement of the exterior walls of up to 36 mm was also apparent. The survey results are shown in Table 1. Monument no. 1 was used as a reference point.

MONUMENT NO.	MOVEMENT FROM 1951-1961	MOVEMENT FROM 1961-1965	MOVEMENT FROM 1965-1982
1	-	-	-
3	-5	-8	+73
7	+30	-6	+39
8	-	-6	+3
9	-	-5	+14
11	-6	-9	+74
12	-10	-16	+136
16	+12	+6	+36

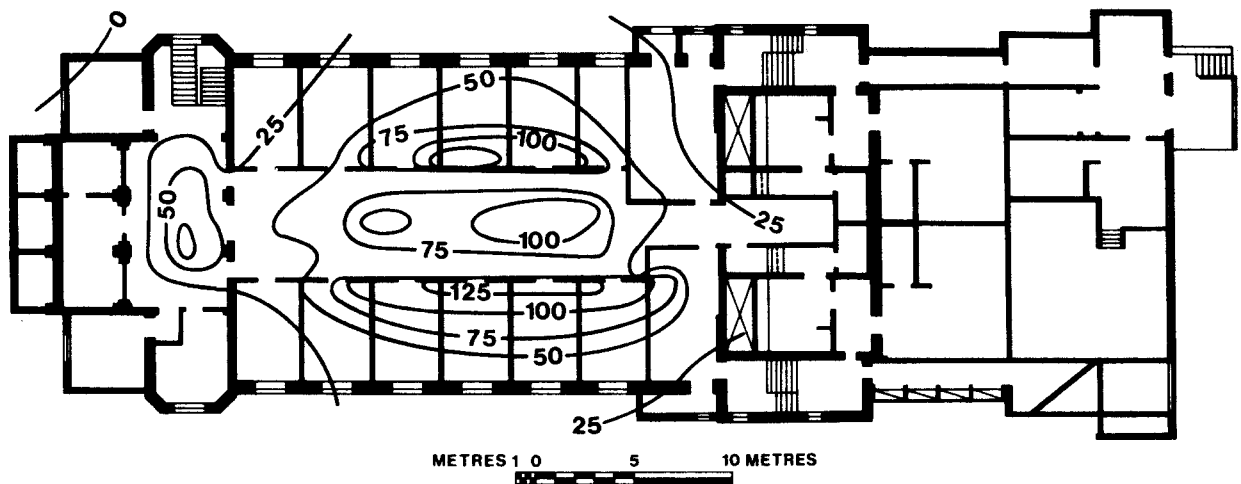
Figure 4 Basement Floor Contours (mm)

Additional surveys including levelling of the basement floor and the underside of the main floor beams, and plumbing of the interior columns were carried out in March and April, 1982. The results are shown in Figures 4 and 5.

The floor survey shows that the corridor floor has heaved as much as 120 mm. The survey of the underside of main floor beams indicated that the interior columns have moved upward between 60 mm and 90 mm with respect to the exterior wall. This could only have occurred as a result of heaving of the interior spread footings. The columns at the southwest end of the corridor were as much as 20 mm out of plumb, with a relative outward displacement at the base of the columns.

The basement floor will be removed and replaced by a crawl space and structural floor slab. Adequate vapour barriers will be included to ensure that desiccation of the soil will not occur. Exterior perimeter drains will ensure that water will be directed away from the footing. Insulation placed outside of the footing and grade beam will decrease the thermal gradients and the degree of moisture movement that will normally take place as a result of steeper thermal gradients (Hamilton, 1969).

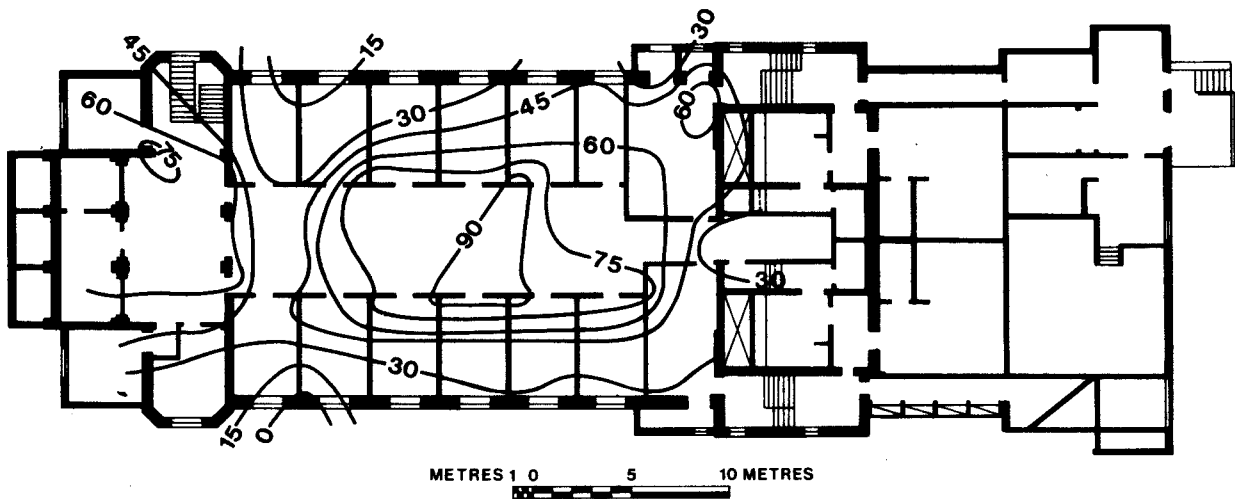
Figure 5 Contours of Underside of Main Floor Beams (mm)

Structural distress and cracking at the interior beam to column connections verifies the observation that the interior columns have moved upward relative to the exterior wall. Concern regarding the structural integrity of these members led to the closing of the main floor auditorium in 1983.

Environmental changes have caused and continue to cause differential swelling and shrinking of the soil, movement of the shallow foundations and subsequent structural damage to Darke Hall. The remedial measures recommended were to underpin the exterior and interior foundation to isolate the structure from the effects of volume changes in the soil as completely as possible. The sensitivity of the structure to additional movement, the uncertainty regarding the construction and construction materials used in the building and the uncertainty surrounding possible environmental changes (principally landscaping) that could result in future movement of the exterior foundations justified the underpinning recommendations.

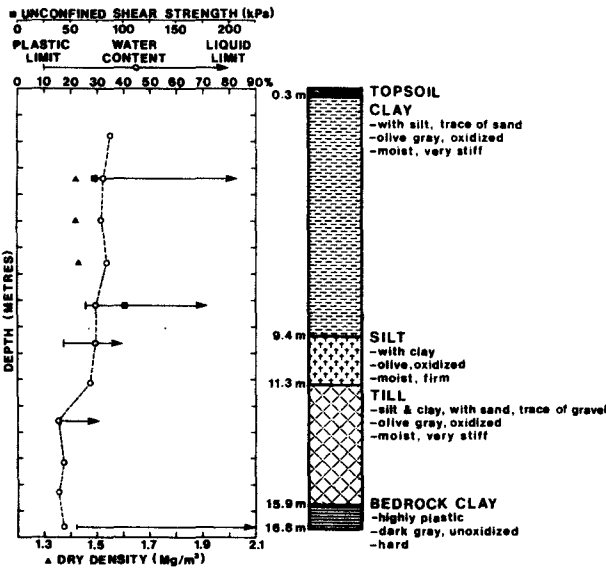
Figure 6 Typical Test Hole Log

A typical test hole log is shown on Figure 6. The surficial material is highly plastic lacustrine clay 9.4 m in thickness. The lacustrine clay is typically unsaturated, expansive and desiccated near the surface by evapotranspiration. The engineering properties of this deposit have been documented (Fredlund et al, 1980). The clay is underlain by a very silty clay stratum 1.9 m in thickness. Underlying these lacustrine deposits are a very stiff, moist oxidized till and an overconsolidated bedrock clay.

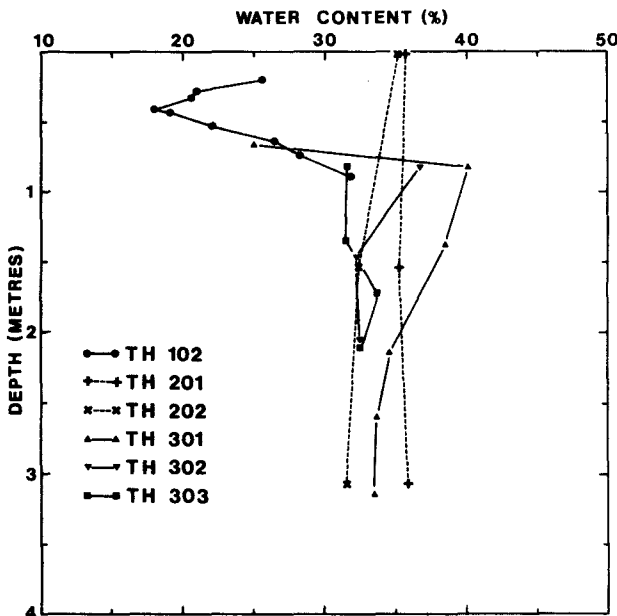
Figure 7 Comparison of Water Contents Across Building

Water contents of 32 percent to 35 percent were encountered to a depth of 4.6 m in exterior test holes drilled immediately adjacent to the footing. The water contents adjacent to the footing in interior test holes was 32 percent to 37 percent, indicating that the water content of the soil across the exterior footings is relatively constant. The water content adjacent to an interior column was 20 percent at the surface, increasing to 30 percent at a depth of 0.8 m, indicating that the soil immediately beneath the slab has likely been desiccated as a result of interior heating. At the centre of the corridor, approximately 1.0 m of highly plastic clay and

sand is present. The water contents in this area ranged from 33 percent to 38 percent with free water being evident. Water content profiles across the building are shown in Figure 7.

contents in the centre of the basement floor corridor indicate a plentiful source of water that has caused swelling of the interior columns that is continuing to date. Although the source of this water is unknown, it is suspected that drains installed under the floor slab, as well as a drain installed during original construction, has hastened the transport of water to the formerly dry interior of the building.

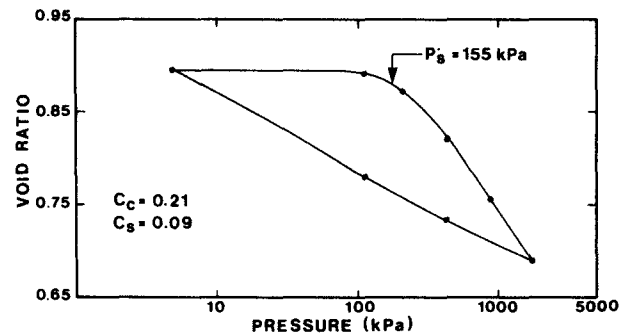
Figure 8 Constant Volume Consolidation Test Result

The results of a constant volume consolidation test are shown on Figure 8. The corrected swelling pressure is  $P'_s = 155$  kPa with a swelling index,  $C_s = 0.09$  and a compressive index,  $C_c = 0.21$ . This specimen was obtained from the exterior of the building at the footing level. Although no consolidation testing was conducted in the area of the interior footing, testing at other buildings in the vicinity indicate that a corrected swelling pressure,  $P'_s = 600$  kPa can be estimated for a water content of 25 percent. For a saturated clay, a water content of approximately 35 percent is typical.
