## Highwall stability analysis under dragline loadings at a Saskatchewan coal mine

**ABSTRACT:** The design of a highwall in coal mining involves the consideration of many factors. The ongoing evaluation of a soft coal strip mine in southern Saskatchewan has provided an opportunity to combine both quantitative and qualitative factors in highwall design.

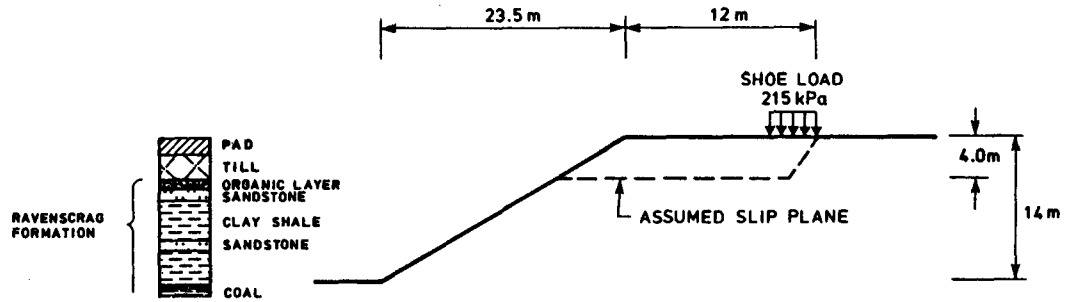
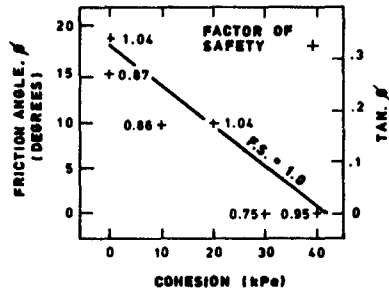
Figure 6. Summary of back-analysis of location TC5

A highwall failure occurred at location TC5 on 20 September 1981. The dragline was walking parallel to the highwall at the time of the failure (Mode 2). A cross-section showing the inferred position of the failure surface, as well as the stratigraphy obtained from a trench log adjacent to the failure is shown in Figure 6.

The failure occurred along a carbonaceous clay layer located approximately 4 m below the bench surface. The failure zone consists of interbedded coal and high plasticity clay. The failure appeared to be a result of the high stresses exerted by the shoe.

Back-analysis of the failure is presented in the form of various cohesion and friction angles which satisfy limit equilibrium conditions (Figure 6). For zero cohesion, the required friction angle was 18 degrees.

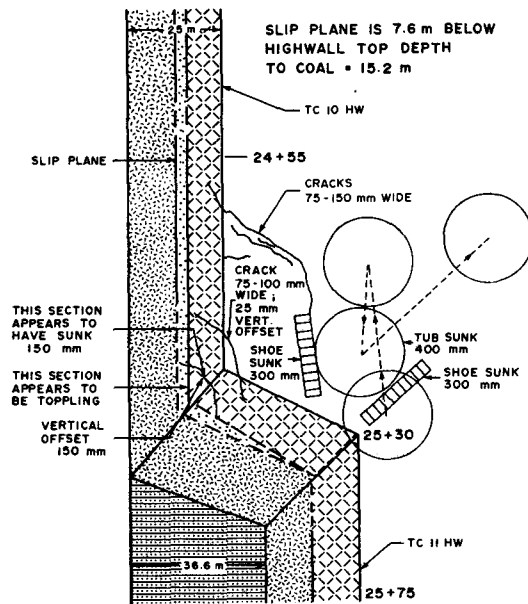
Figure 7. Plan of location TC10 showing the crack patterns

A highwall failure occurred at location TC10 on 22 September 1982. The TC10 failure is illustrated in Figure 7 which shows a plan view of the crack patterns. The inferred cross-section in the vicinity of the failure is

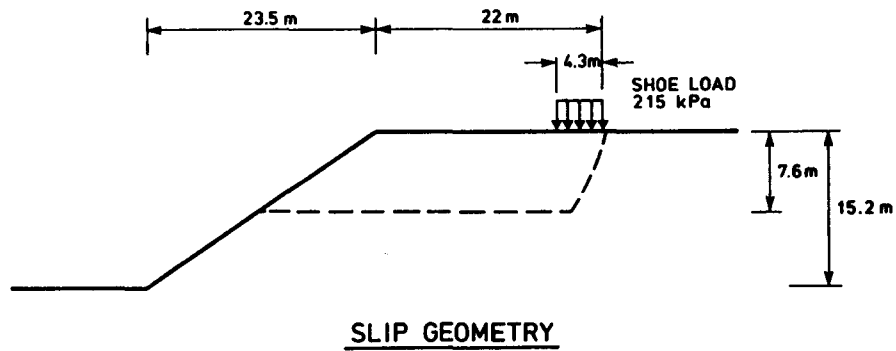
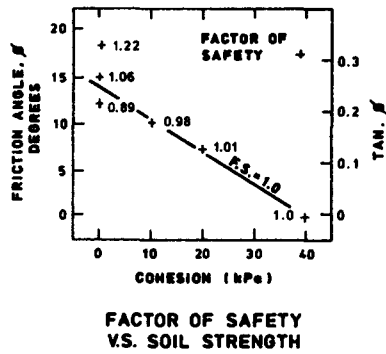
Figure 8. Summary of back-analysis of location TC10

shown in Figure 8. The slip plane was located in a slickensided, high plasticity clay at a depth of 7.6 m below the bench.

The results of the back-analysis are also summarized on Figure 8. The friction angle at failure, computed for a zero cohesion intercept, was 14 degrees.

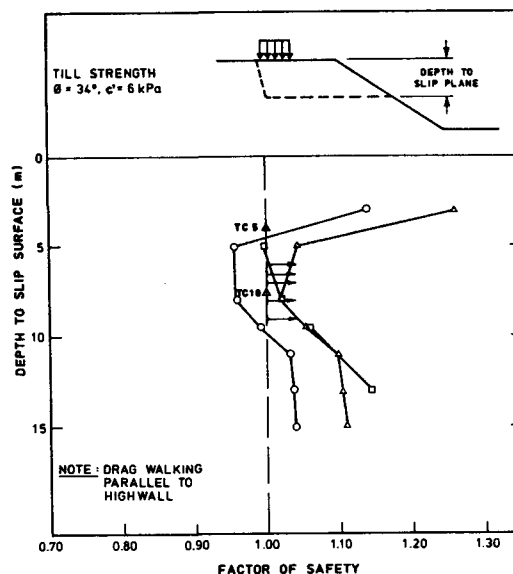
Figure 16. Factor of safety versus depths to the slip surface for differing soil strengths

The results of the limit equilibrium stability analysis are summarized in Figure 16. Stability analyses were carried out for weak layers at depths ranging from 2 to 15 m. Separate analyses were carried out for effective friction angles of 14 degrees and 16 degrees along the weak zone.

The minimum factor of safety occurs for a slip plane at a depth between approximately 4 to 11 m. For an effective friction angle of 16 degrees and for a slip

surface at a depth of 5 m, the factor of safety was 1.04. For the same slip surface and with a friction angle of 14 degrees, the factor of safety was approximately 0.96. The factor of safety increased above unity at depths greater than 11 m for the range of soil strengths analyzed.

The results of a similar analysis for a 2:1 slope and a 14 degree friction angle are also shown in Figure 16. The 2:1 slope is only marginally more stable than the 1.5:1 slope. The small increase in stability results from a small relative increase in the length of the failure surface for the flatter slope. At greater depths, there is a greater relative increase in the length of the slip surface. Therefore, the increase in stability is greater at increased depths to the slip surface.
