#### STABILITY OF SWELLING CLAY EMBANKMENTS

Presented at the 29th Canadian Geotechnical  
Conference  
Vancouver, British Columbia  
October 13 to 15, 1976

The long history of slope instability in Regina clay has prompted an in-depth study of the embankments at Belle Plaine, Saskatchewan. This paper presents the history, material characterization and analysis of the landslides at Belle Plaine.

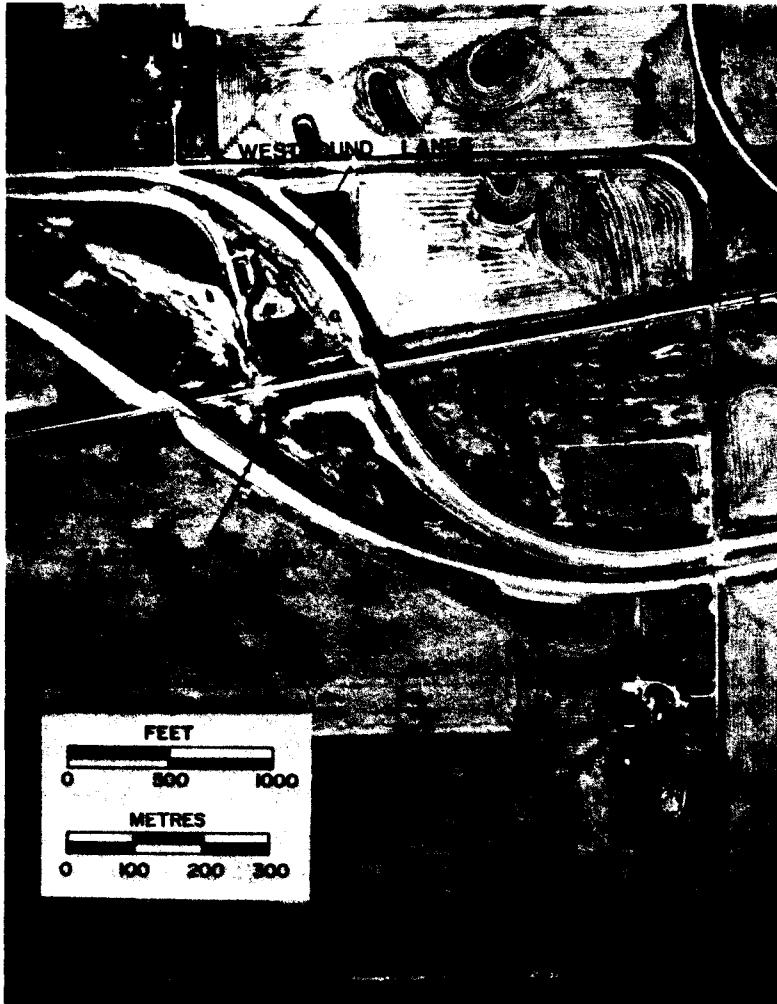
FIG. 1 OVERPASS LAYOUT AT BELLE PLAINE,  
SASKATCHEWAN

In 1965 construction was started on a new embankment for an eastbound lane. During the construction of the eastbound overpass, a deep borrow pit was excavated at the toe of the old fill (Point 'a' in Figure 1). This increased the effective height of the old fill to 50 feet (15.2 m). In 1966 the eastbound overpass was completed with 3:1 side slopes and a maximum fill height of about 30 feet (9.1 m). It was paved the same year and overlaid in 1968.

In the fall of 1968, two landslides occurred on the northeast side of the westbound lanes (Point 'b') and a minor slide occurred west of the overpass on the westbound lanes (Point 'c'). Cracking accelerated in the fill directly above the borrow pit (Point 'd'). In the spring of 1969, a landslide about 300 feet (91 m) long that involved about half the height of the slope occurred above the borrow

pit (Point 'd'). The slide was accompanied by new cracking along the shoulder and in the driving surface. Cracks from 3 to 4 inches (76 to 102 mm) wide opened on the shoulder and cracks 1 inch (25 mm) wide opened in the driving mat.

During the summer of 1970, the slide above the borrow pit (Point 'd') was repaired and part of the borrow pit (Point 'a') was filled. With the repair fill less than 10 feet (3 m) above the natural ground, tension cracks started to appear near the base of the approximately 4:1 slope. Fill was halted, but movements continued on a slide block 200 to 300 feet (61 to 91 m) long. The slide extended about 100 feet (30 m) inward from the toe of the fill and comprised a volume of about 15,000 cubic yards (11,500 m<sup>3</sup>). The vertical displacement was 3 to 4 feet (0.9 to 1.2 m) at the scarp and the horizontal displacement appeared to be similar. The toe of the slide pushed out approximately 15 feet (4.6 m) below natural ground level or 2 feet (0.6 m) above the water level in the old borrow pit. The rear scarp roughly followed

On June 23, 1970, the Saskatchewan Department of Highways used a rotary drill to advance a testhole through the fill on the east abutment of the westbound lanes (Testhole #3-70, Figure 1). The upper 35 feet (10.7 m) was a highly plastic clay fill. The average liquid limit was 80 percent, the average plastic limit 42 percent and the average shrinkage limit 12 percent. The average water content in the upper 15 feet (4.6 m) was 34.5 percent, decreasing with depth to 29 percent. The average unconfined compressive strength of the fill material was 15.2 psi (105 kN/m<sup>2</sup>). In situ Regina Clay was encountered from 35 feet (10.7 m) to a depth of approximately 55 feet (16.8 m). The natural material had an average liquid limit of 86 percent and an average plastic limit of 35 percent. The average natural water content was 24.4 percent and the average unconfined compressive strength was 70 psi (480 kN/m<sup>2</sup>). A dark grey brown, sandy clay till was encountered from 55 feet (16.8 m) to the bottom of the testhole (i.e. 76 feet or 23.2m).

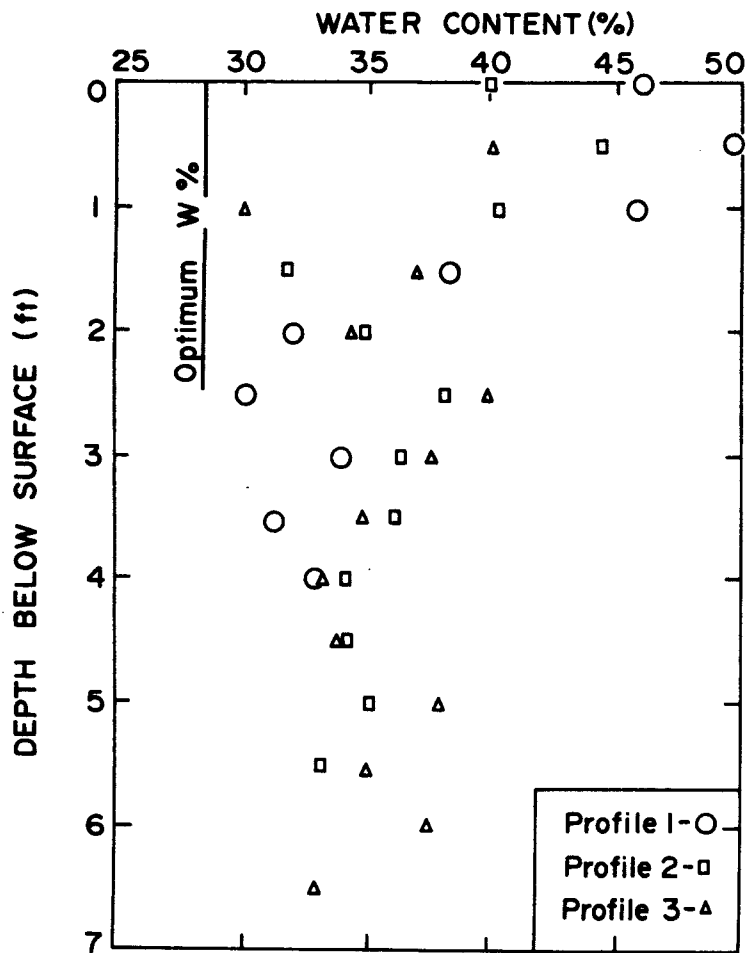
FIG. 7 WATER CONTENT VERSUS DEPTH BELOW SURFACE FROM TRENCH

A backhoe was used on May 16, 1974 to make a trench approximately 8 feet (2.4 m) deep through the slide along line A. The scarp could be readily observed for the first 4 feet (1.2 m) into the fill. Due to the wet, fissured nature of the clay, it was difficult to accurately determine the remainder of the slip surface. The highly disturbed zone indicated that the base of the slide was approximately 7 to 8 feet (2.1 to 2.4 m) below the surface. The failure surface was essentially circular with the exception of the base portion which was slightly composite due to the thaw front. The toe slid out horizontally over the natural ground. Ice lens were encountered in some of the fissures and the backhoe dragged out large, frozen chunks of clay. A definite change in the soil structure from "nuggetty" to "massive" was noted between the top and bottom of the trench. Water content samples were taken at 6 inch (152 mm) depth intervals along the side of the trench. From three profiles (T-A-1, T-A-2, T-A-3), along the trench (Figure 4), the average of 34 water contents was 36.6 percent (Figure 7).

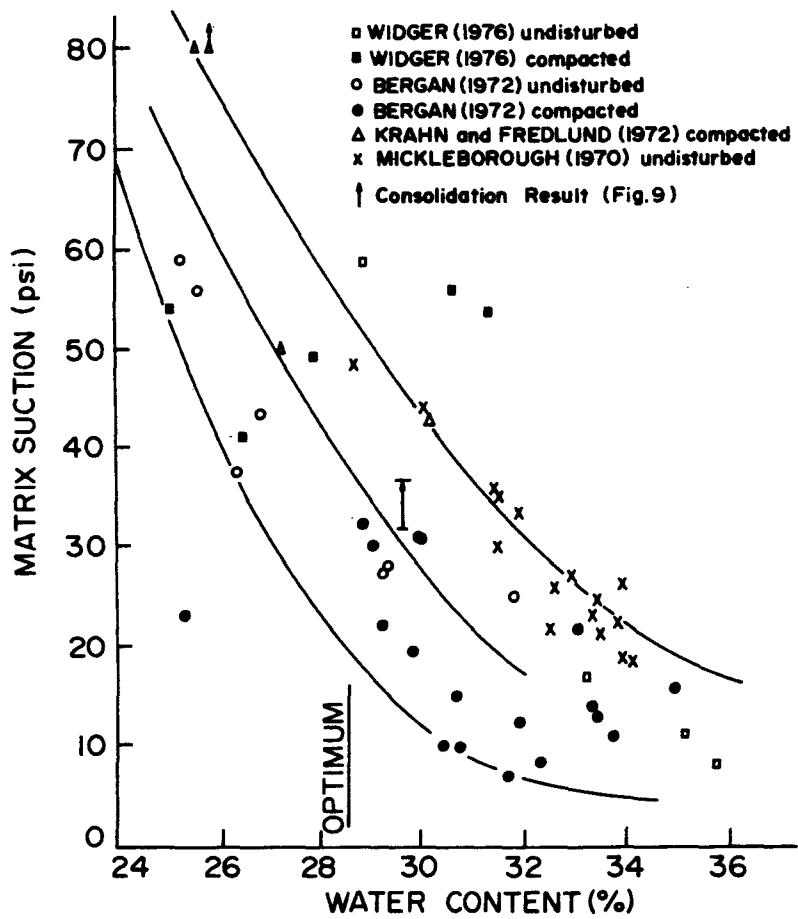
FIG. 8 MATRIX SUCTION VERSUS WATER CONTENT FOR REGINA CLAY

water content results in a decrease in the matrix suction of the soil and correspondingly, a reduction in strength. Figure 8 shows a collection of matrix suction measurements plotted versus water content for Regina Clay. The tests were performed on a pressure plate apparatus (Pufahl, 1970). Some samples tested were from the Belle Plaine overpass (Widger, 1976) while others were on Regina Clay samples with similar classification properties. Also shown is one matrix suction estimation from a one-dimensional consolidation test performed on a sample compacted near optimum water content. Figure 9 shows the construction to evaluate the state of stress (Fredlund, 1975).

Using mean values, the matrix suction near optimum water content is 39 psi (270 kN/m<sup>2</sup>). The average water content at failure was 37.6 percent which corresponds to a matrix suction of approximately 8 psi (55 kN/m<sup>2</sup>). The reduction in matrix suction is believed to be first caused by a freeze-thaw cycle that establishes a nuggetty or fissured macro-structure (Mickleborough, 1970). Subsequent ingress of water into the macro-structure causes a further reduction in matrix suction.

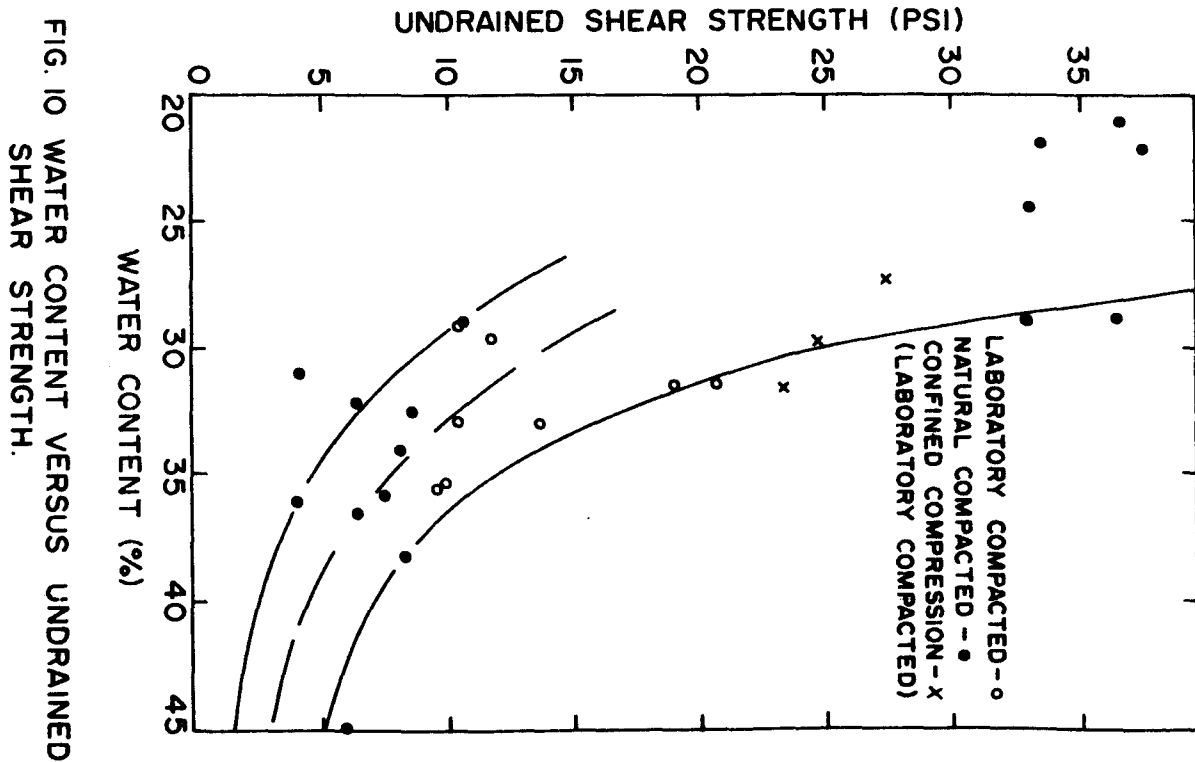
FIG. 10 WATER CONTENT VERSUS UNDRAINED SHEAR STRENGTH.

Table II summarizes the shear strength testing program. The undrained shear strength of Regina Clay was evaluated from unconfined compression tests on laboratory and field compacted samples at various water contents (Figure 10). The scatter is believed primarily due to the effects of secondary structure in the samples. Using the best-fit curve, the undrained shear

strength at the time of construction was approximately 17 psi (117 kN/m<sup>2</sup>). At the time of failure, the undrained shear strength would be approximately 6 psi (41 kN/m<sup>2</sup>). The lower limit curve for all values gives a shear strength of approximately 3.5 psi (24 kN/m<sup>2</sup>) at the time of failure.

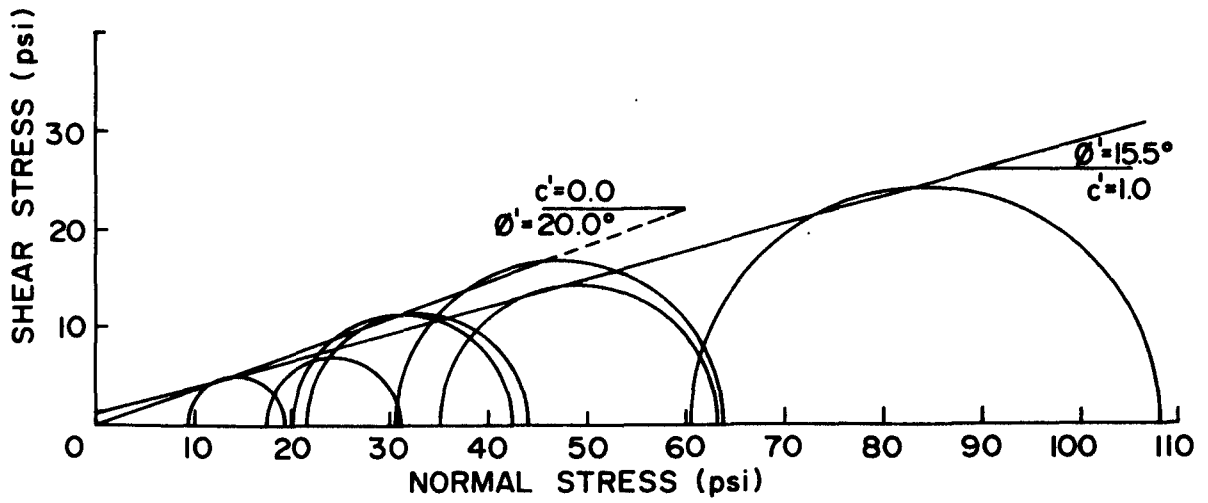
FIG. 14 PEAK EFFECTIVE STRENGTH ENVELOPE FOR SERIES W

The W series of triaxial tests were trimmed from the undisturbed block sample taken from the failure plane at Belle Plaine. All specimens exhibited a brittle type of failure, forming a slicked failure surface. Table V shows the triaxial data at peak and large strain conditions. Figure 14 shows the peak effective strength envelope and Figure 15 shows the large strain (i.e. approximately 12 percent) effective strength envelope. Under peak conditions, the effective angle of internal friction varies from 15.5 to 20 degrees with the effective cohesion varying from 1 to zero psi (7 to 0 kN/m<sup>2</sup>) respectively.

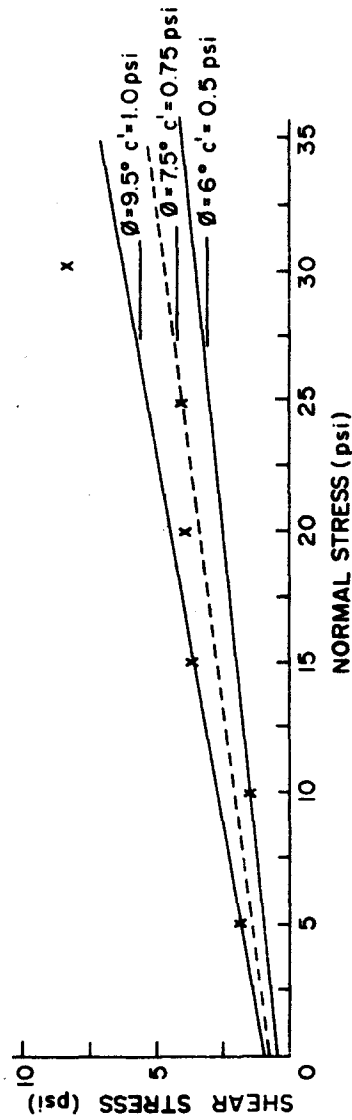
FIG. 16 RESIDUAL SHEAR STRENGTH PARAMETERS FROM DIRECT SHEAR TESTS

A series of direct shear tests were performed on 2 inch (51 mm) square specimens cut from thin-walled tube samples taken approximately at the shear surface. Seven direct shear tests were performed at unit normal pressures ranging from 5 to 35 psi (34 to 241 kN/m<sup>2</sup>). All failed specimens had slickensided and somewhat wavy surfaces. The samples were subjected to six cycles of 0.2 inch (5 mm) displacements at a rate of strain of 0.1 inches (2.5 mm) per hour. Figure 16 shows the residual shear strength envelope. The best-fit envelope gives a residual friction angle of 7.5 degrees and a cohesion of 0.75 psi (5.2 kN/m<sup>2</sup>).
