# Performance of Darke Hall, Regina, Canada, Constructed on a Highly Swelling Clay

**SUMMARY** A case history describing the performance of a lightly loaded structure supported by a shallow foundation in an unsaturated expansive soil is presented.

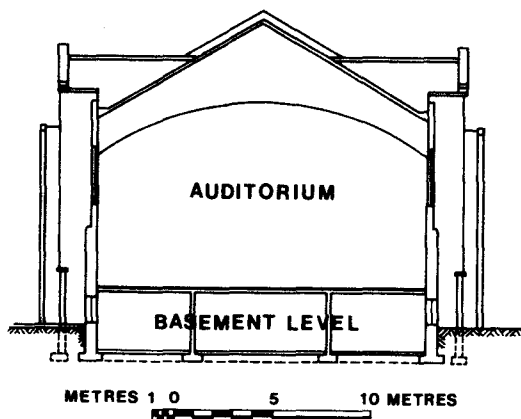
Figure 3 Section Through Darke Hall

Structural distress and cracking at the interior beam to column connections verifies the observation that the interior columns have moved upward relative to the exterior wall. Concern regarding the structural integrity of these members led to the closing of the main floor auditorium in 1983.

Environmental changes have caused and continue to cause differential swelling and shrinking of the soil, movement of the shallow foundations and subsequent structural damage to Darke Hall. The remedial measures recommended were to underpin the exterior and interior foundation to isolate the structure from the effects of volume changes in the soil as completely as possible. The sensitivity of the structure to additional movement, the uncertainty regarding the construction and construction materials used in the building and the uncertainty surrounding possible environmental changes (principally landscaping) that could result in future movement of the exterior foundations justified the underpinning recommendations.
