## Highwall stability analysis under dragline loadings at a Saskatchewan coal mine

**ABSTRACT:** The design of a highwall in coal mining involves the consideration of many factors. The ongoing evaluation of a soft coal strip mine in southern Saskatchewan has provided an opportunity to combine both quantitative and qualitative factors in highwall design.

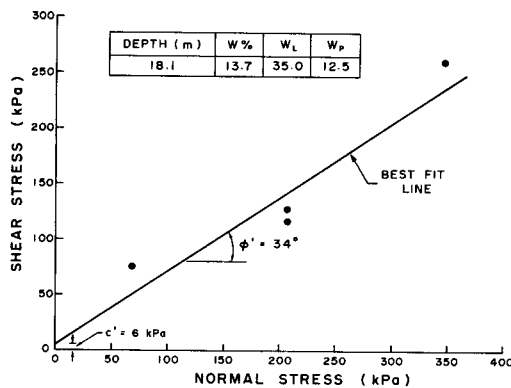
Figure 2. Direct shear test results on the till

The soil properties of primary interest are the shear strength of the till and the slickensided clay zones. Direct shear testing was performed on samples of the till taken from near the power plant (Figure 2). The effective cohesion intercept was 6 kPa and the effective friction

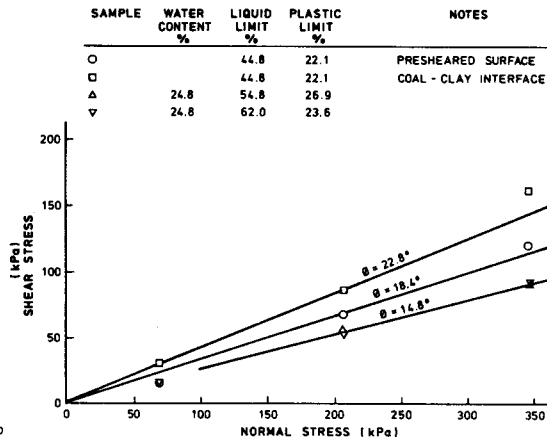
Figure 3. Direct shear test results on sample from location TC14 on the coal-clay interface

The direct shear test results are summarized in Table 1. Table 1 also includes some shear strength parameters obtained from back-analysis of highwall failures. These are discussed later in the paper. The friction angle and plasticity characteristics vary substantially. Three direct shear tests were carried out on samples obtained from a weak layer of highly plastic, carbonaceous clay (sample TC14). The results of these tests are presented in Figure 3. Effective friction angles ranging from 14.8 degrees to 22.8 degrees were measured. The higher friction angles represent strengths along shear planes in the clay-coal interface. The specimens tested were from 100 mm diameter, undisturbed tube samples.

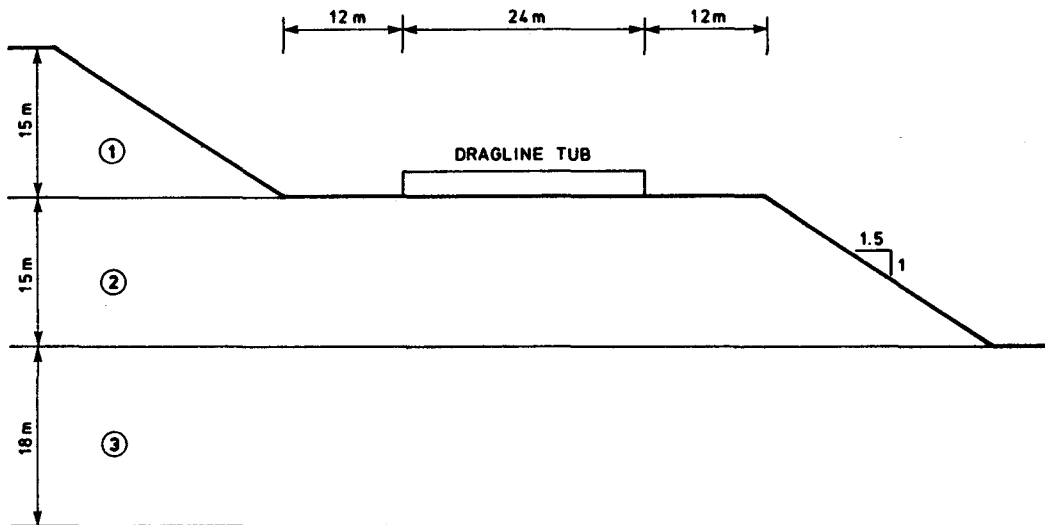
Figure 9. Summary of the geometry and the soil properties used in the finite element stress analysis

The soil properties used in the stress analysis are shown in Figure 9. The elastic moduli were estimated. The calculated stress ratios are relatively insensitive to the magnitudes of the moduli selected. In all cases, the soil adjacent to the pit wall was overstressed for approximately 10 m from the highwall slope. This overstressing is a result of excavation and slope unloading.

LAYER	YOUNG'S MODULUS (kPa)	POISSON'S RATIO	UNIT WEIGHT (kN/m <sup>3</sup> )
1	124,000	0.3	19.3
2	249,000	0.3	19.3
3	689,000	0.3	19.3

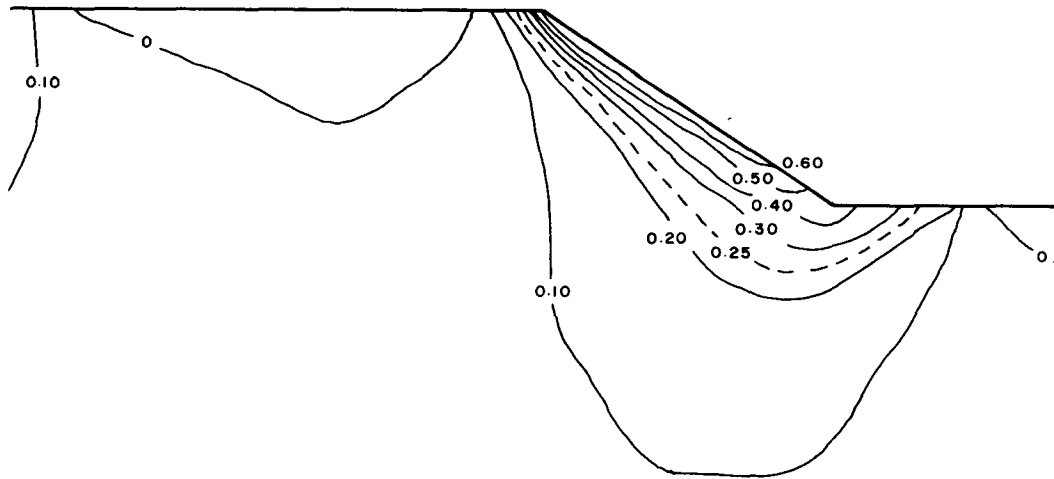
Figure 10. Contours of  $\tau_{yx}/\sigma_y$  for loading Mode 1

Stress contours for this case of loading are shown in Figure 10. There are no loads acting on the bench. The slope is overstressed for approximately 2 m to 8 m from the highwall slope.

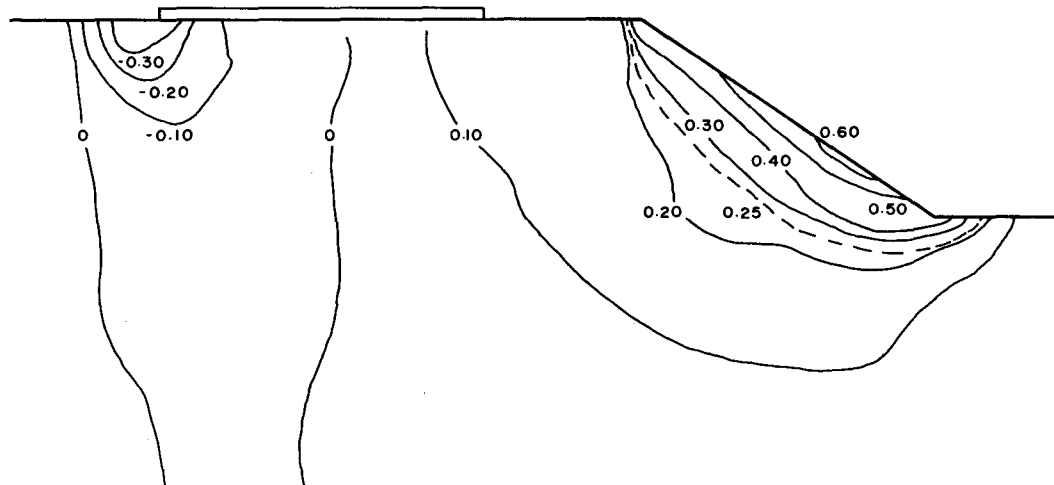
Figure 11. Contours of  $\tau_{yx}/\sigma_y$  for loading Mode 2

In this case the weight of the dragline is exerted uniformly across the tub. There are no shoe stresses. The stress contours are shown in Figure 11. The slope is overstressed for a distance extending about 10 m from the highwall crest as a result of excavation unloading. A small, local overstressed region is present near the tub edge.

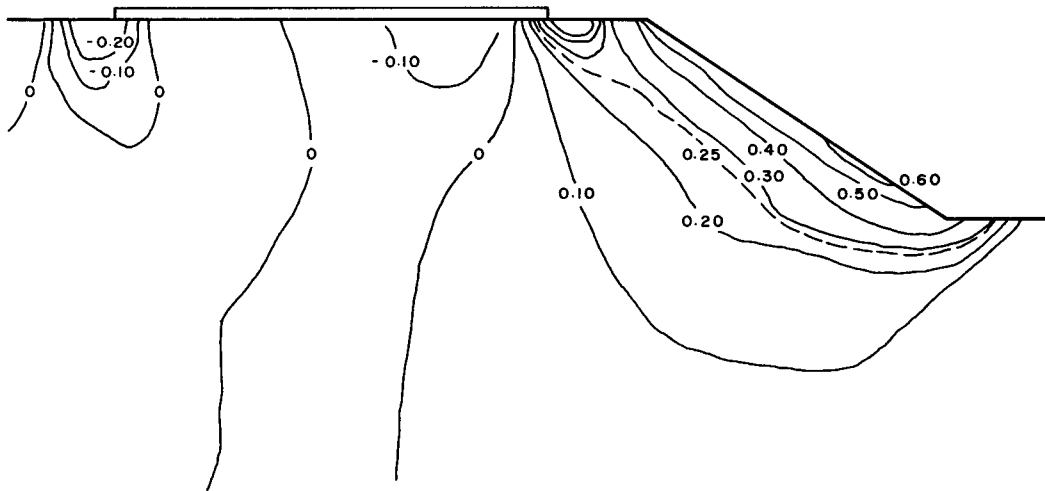
Figure 12. Contours of  $\tau_{yx}/\sigma_y$  for loading Mode 3a

12 m from the highwall, are shown in Figure 12. Similar contours, when the tub is 9 m from the highwall, are shown in Figure 13. An overstressed zone occurs, extending for a distance of approximately 10 m into the bench platform from the highwall crest. A larger and more heavily overstressed region exists under the exterior shoe. With the tub 12 m from the highwall, the overstressed zones coalesce and form a continuous zone which exists from beneath the shoe to the highwall, down to a depth of approximately 5 to 6 m. It would appear that failure would occur within this zone if a weak layer were present. With the tub 9 m from the highwall, the overstressed zone is larger, and exhibits higher stress ratios.

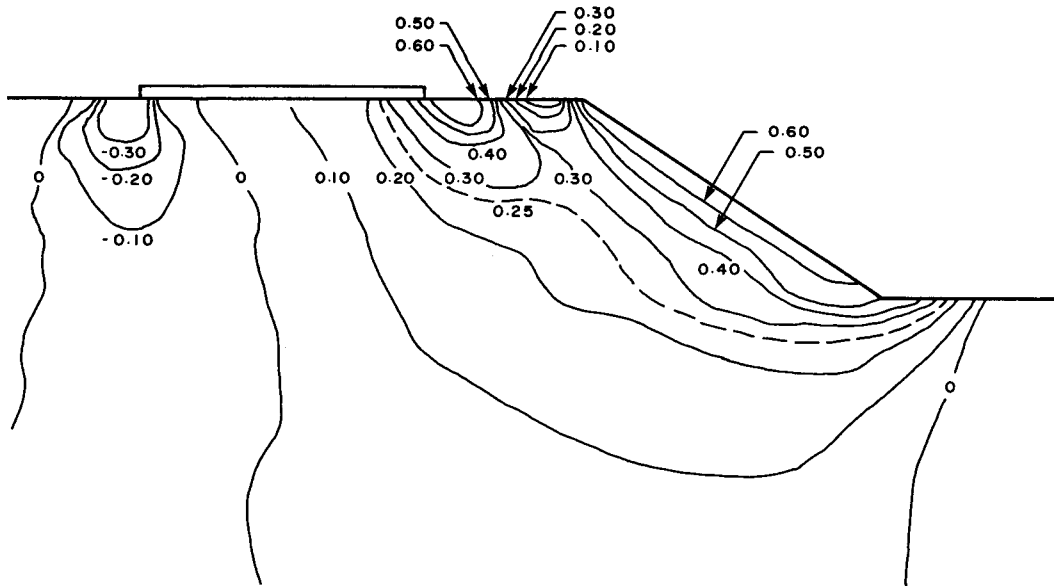
Figure 14. Contours of  $\tau_{yx}/\sigma_y$  for loading Mode 4

Contours for this case are shown in Figure 14. Larger overstressed regions are indicated. These conditions are representative of the maximum stresses that occur through the shoe. However, the conditions are not completely representative of those that exist across a large section of the highwall. The stress analysis does show, however, that the outward thrust tends to increase the overstressed region and, therefore, reduces the overall stability of the slope.

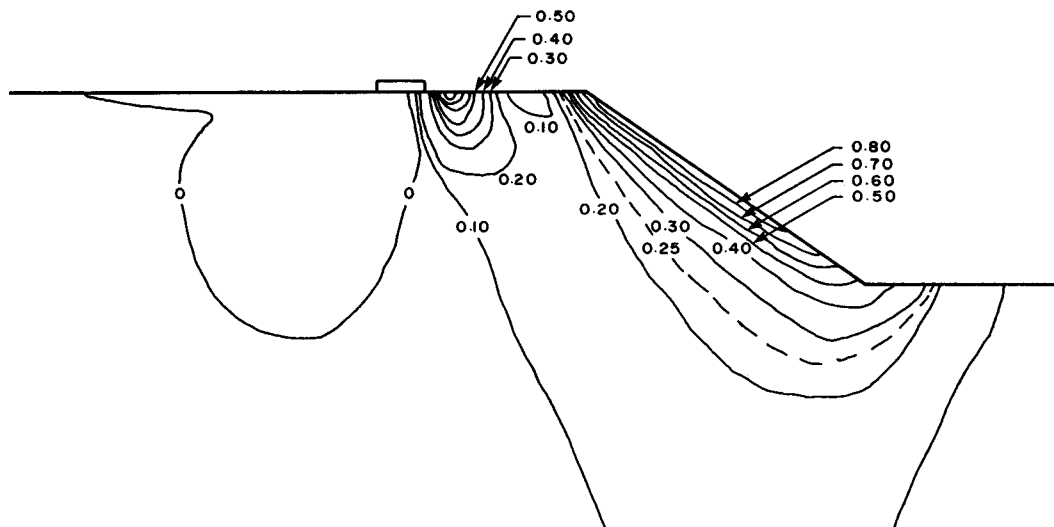
Figure 15. Contours of  $\tau_{yx}/\sigma_y$  for loading Mode 5

When the dragline walks perpendicular to the highwall at high cam position, only a portion of the tub is in contact with the bench. Assuming that 30 percent of the total load acts on this contact area, an average stress of 414 kPa is estimated. The shape of the stress distribution was assumed to be triangular, acting over a distance of 3.7 m perpendicular to the highwall.

An overstressed zone is indicated in Figure 15. The

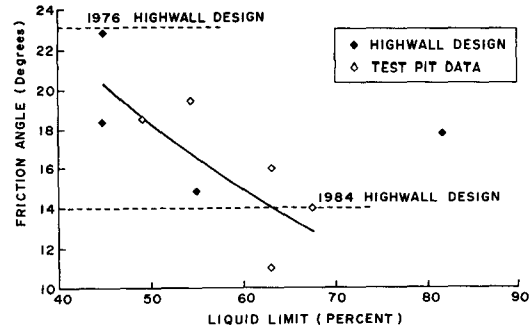
Figure 17. Summary of the friction angle versus the liquid limit for the badrock clay at the coal mine site

The principal factor in the stability of the slope is the shear strength of the soils, particularly the strength of the principal layer in which the failure surface develops. High, peak shear strength values may be used in hard undisturbed materials, but residual shear strength values may be required in the presheared zones. Figure 17 illustrates how the design values for the clays have changed since the initial study. The 1976 mine design was predicated on fully softened strength values ( $c' = 0$ ) for the highwall, assuming the average strength in the highwall would be intermediate, between the peak and residual strength of the clays.

The design value for the weak, sheared layers has been reduced on subsequent re-analysis of 1984 highwall failures, until a value of 14 degrees was calculated. This value was utilized for the design of berms which would support the highwalls where the existence of shear planes was recognized.
