RETROGRESSIVE SLOPE FAILURES
NEAR SASKATOON

M.D. HAUG
E. KARL SAUER
D.G. FREDLUND

UNIVERSITY OF SASKATCHEWAN
SASKATOON

PRESENTED TO THE 29TH CANADIAN
GEOTECHNICAL CONFERENCE
VANCOUVER, BRITISH COLUMBIA
OCTOBER 13 TO 15, 1976

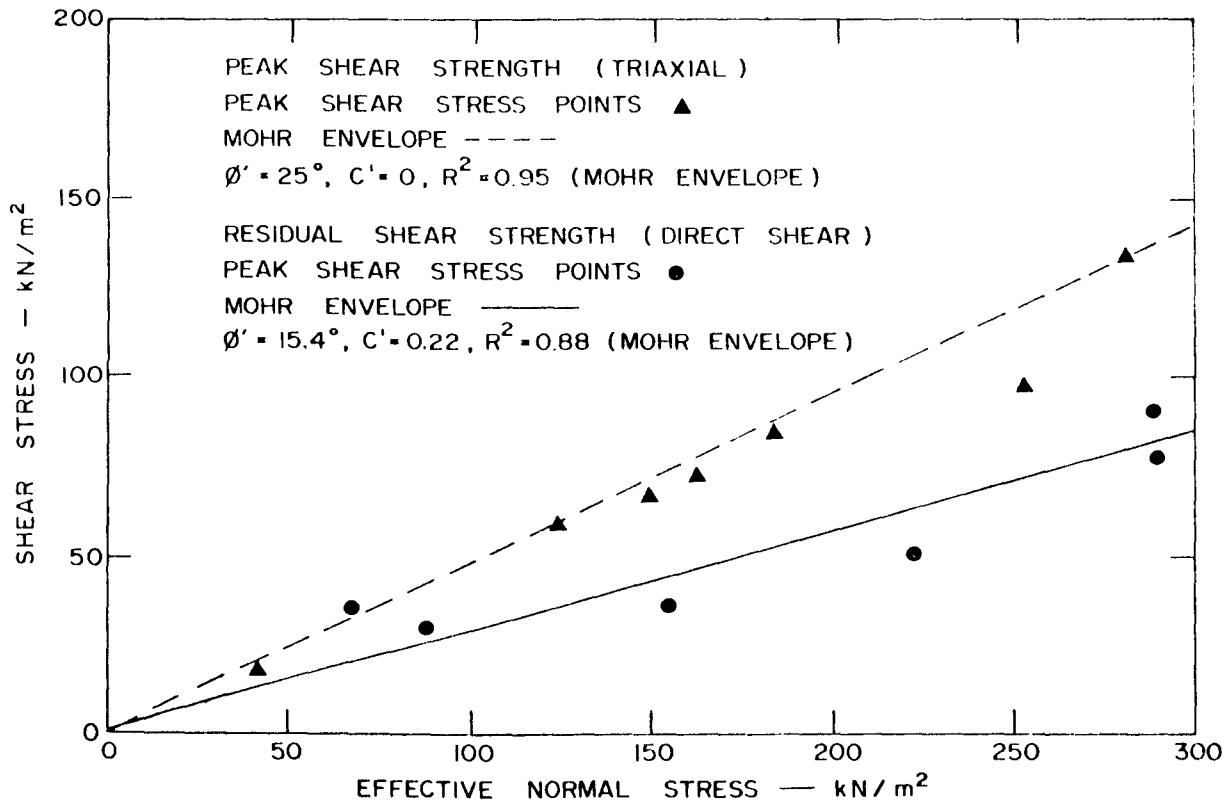
ELEVATION - METRES

Residual shear strength values were used to analyze the block at the toe of the slide because the block is moving. The results indicated that the lower block of the slide is unstable having a factor of safety against sliding of 0.78. Following blocks were then analyzed with the assumption described above and all were found to have factors of safety less than one (Figure 17).
