A.W. Clifton

Experiences with Two Fills on Clay Shale Foundations

**Conference on Soil Mechanics and Foundation Engineering, October 29-November
3, Guadalajara, Mexico. 1995**

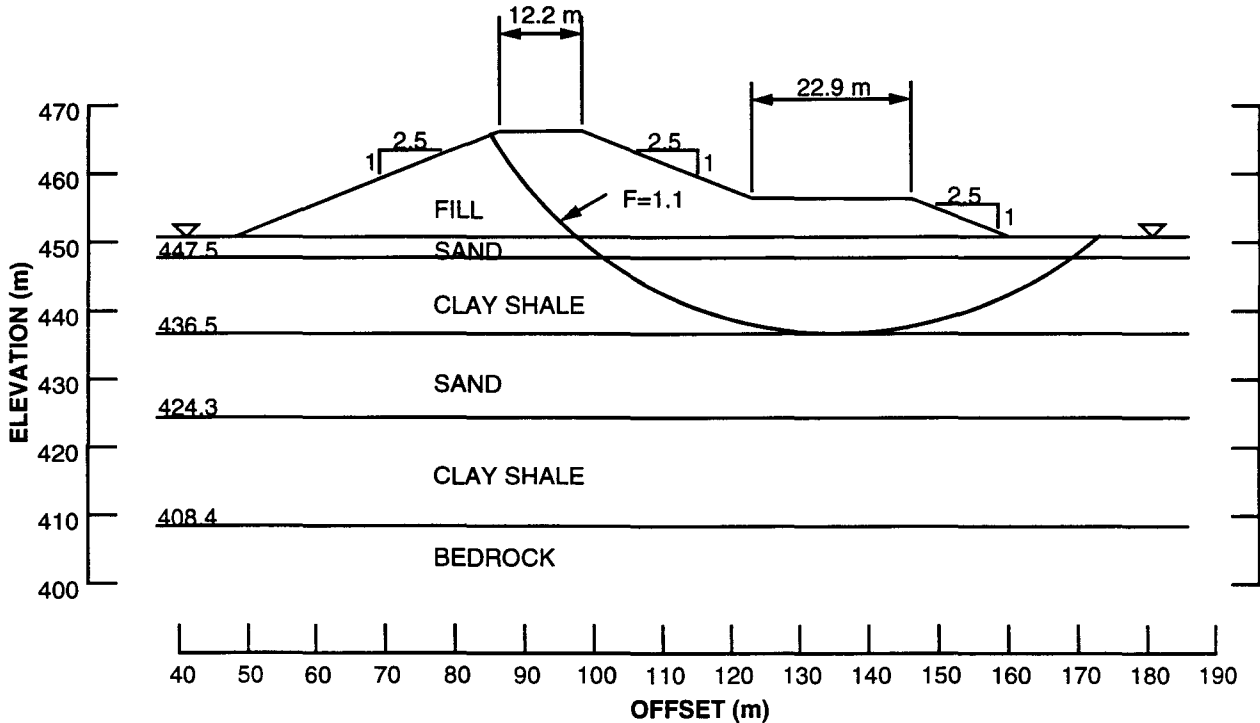
The approach fill had a maximum height of approximately 15 m. The most crucial section of the foundation was comprised of disturbed clay shale which overlaid and was overlain by alluvial sand as indicated in Figure 3.

Fig. 3 Typical Geometry of South Approach Fill, Maymont Bridge (Clifton, 1994)

Earthwork in the vicinity of the bridge abutment and other critical areas were designed with conventional factors of safety, but a lower factor of safety, approximately 1.1, was utilized for lateral stability of fills where the consequence of failure was low. Typical fill geometry is illustrated in Figure 3.

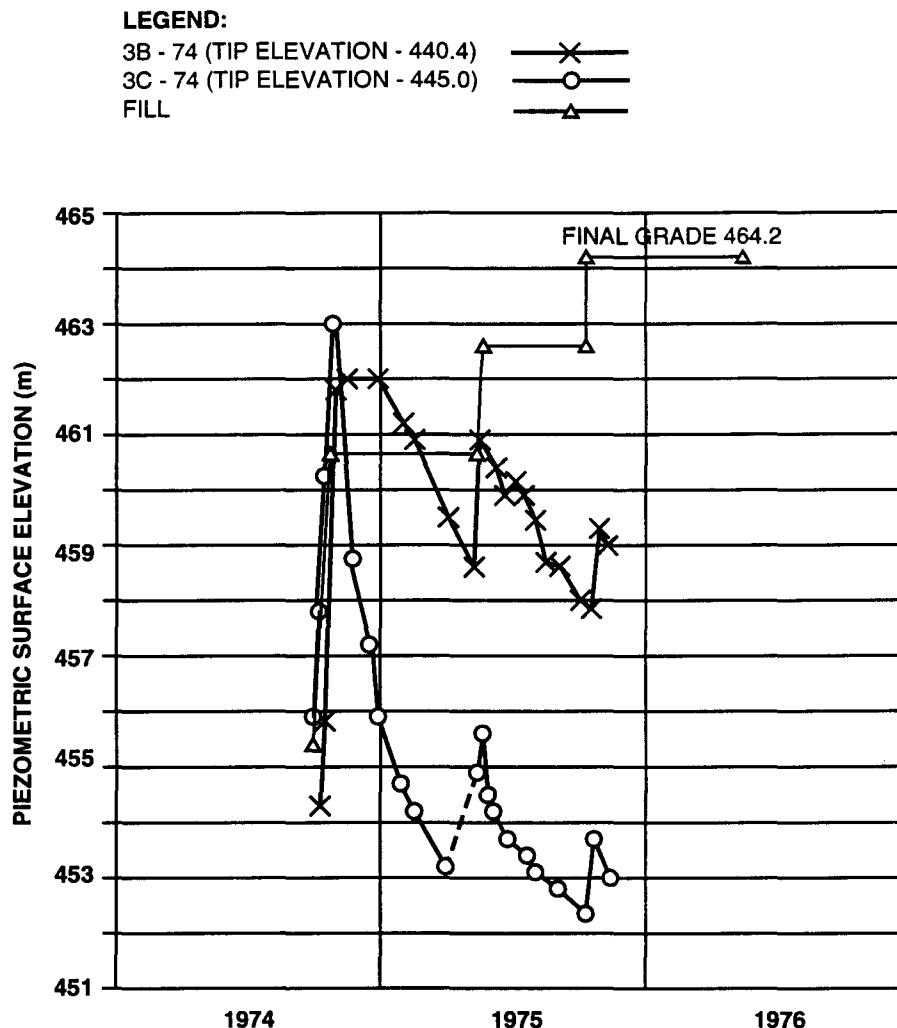
Fig. 4 Typical Fill Elevation and Construction Pore-water Pressures, South Approach Fill, Maymont Bridge (Clifton, 1993)

Construction of the fill commenced in 1974 and was completed in 1975. The typical rate of fill advance and resulting foundation pore-water pressures are illustrated in Figure 4.
